Manhole Inspection Summary

Manhole # S63I__018MH

Insp Date: **5/14/08 1:02 PM**

Location Address: **603 Umbra St.**

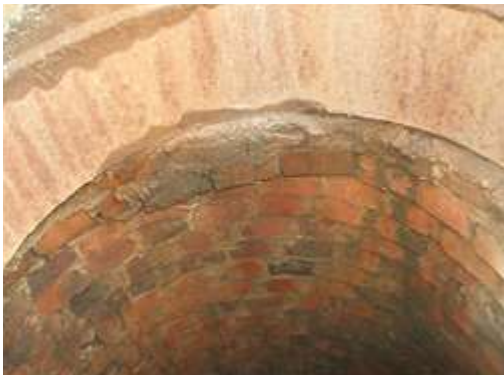
Defect 2

Infiltration: ☐ None ☒ **Joint** ☐ Cracks ☒ **Mortar** ☐ Roots ☐ Wall

infiltration on frame

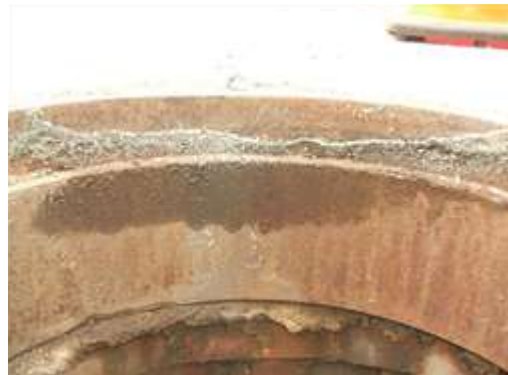
Defect 4

infiltration at manhole lid

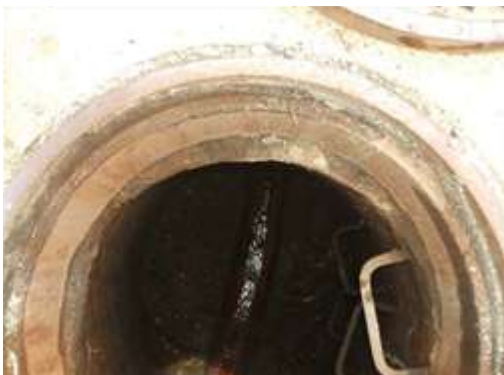
Defect 1

Frame Offset: **2** (in.) Condition: ☒ Sound ☐ Cracked ☐ Leaks

frame offset

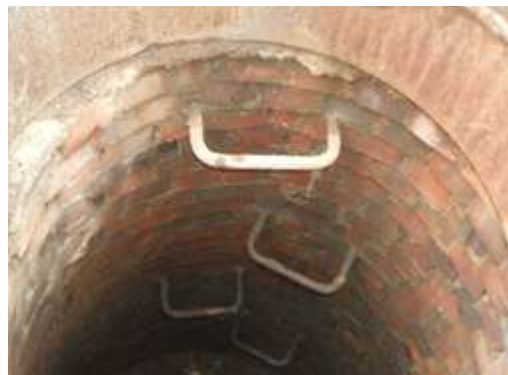
Defect 3

Infiltration: ☐ None ☒ **Joint** ☐ Cracks ☒ **Mortar** ☐ Roots ☐ Wall

infiltration through brick wall in barrel

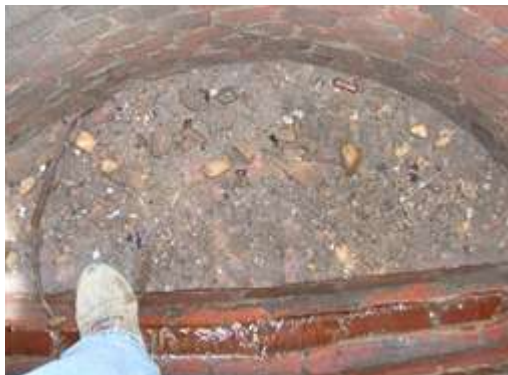
Defect 5

Condition: ☐ Sound ☐ Cracked ☐ Root Intrusion ☐ Deteriorated ☐ Leaks ☒ **Debris**

debris
